# asphalt

## Quality. Right from the Start

Deutscher Asphaltverband e.V.  
(German Asphalt Paving Association)  
Schieffelingsweg 6  
53123 Bonn  
Germany

August 2007, english translation 2011

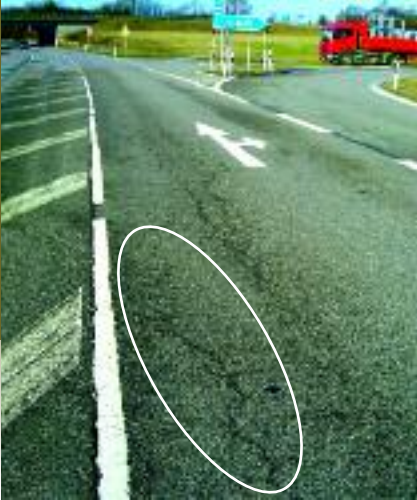
**Description:**

Very large, deep cracks, partly with localized deformations

- Poor bearing capacity of granular sub-grade/sub-base
- Routing of heavy traffic
- Loads are not transmitted within the structure
- Subgrade failure

- Degradation of surface course
- Water ingress damages the pavement structure and the layer bonding

- Rehabilitate the failed structure
- Repair cracks and apply a thin overlay (as intermediate solution)

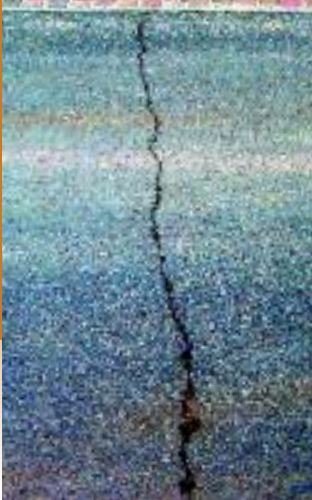
## 2.2 Asphalt overlay on hydraulically-bound (roller-compacted) layers (HBL)

**Description:**  
Cracking and disintegration of the surface course

Prevention tips
<ul style="list-style-type: none"><li>■ Pressure resistance of HBL is too high</li><li>■ Lack of/insufficient rubblizing of the hydraulically-bound base</li><li>■ Premature overlay</li><li>■ Overlay is too thin</li><li>■ Non-compliance with the type test for HBL</li><li>■ Reflective cracking</li></ul>	<ul style="list-style-type: none"><li>■ Destruction, distortion and disintegration of asphalt surface course</li></ul>	<ul style="list-style-type: none"><li>■ Crack sealing. Widen cracks with router, if need be.</li><li>■ Remove the affected area and apply a new layer</li></ul>	<ul style="list-style-type: none"><li>■ Ensure targeted rubblizing (heavy roller, kerbs)</li><li>■ Observe the minimum curing time for base</li><li>■ Ensure uniform strength of base course</li><li>■ Review and select the required overlay thickness and material</li></ul>

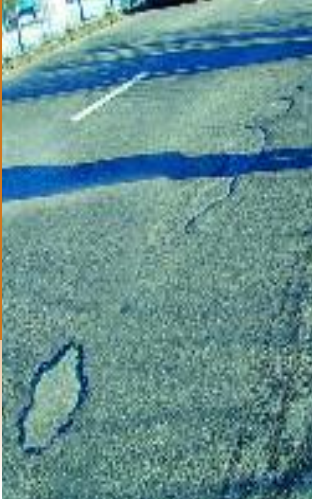
## 2.4 Asphalt overlay on existing asphalt surface

**Description:**  
Cracking, disintegration and distortion of surface course

Prevention tips
<ul style="list-style-type: none"><li>■ Poor layer bonding (with and within underlying structure)</li><li>■ Insufficient load-bearing capacity (of entire layer and localized areas)</li><li>■ Overlay was placed on existing surface course which had then to take over the function of the binder course</li><li>■ Overlay is too thin</li><li>■ Reflective cracking following the underlying pavement</li><li>■ Inadequate repairs of failed sections in existing pavement</li></ul>	<ul style="list-style-type: none"><li>■ Progressive degradation of asphalt surface course</li></ul>	<ul style="list-style-type: none"><li>■ Fill cracks with crack-sealing material</li><li>■ Reinstate/rehabilitate failed areas</li></ul>	<ul style="list-style-type: none"><li>■ Remove old surface course to the extent possible</li><li>■ Review overlay thickness</li><li>■ Roughen smooth pavement surface</li><li>■ Thoroughly clean the existing surface</li><li>■ Repair existing pavement cracks (crack filler, membranes)</li><li>■ Select the appropriate type and amount of tack coat material</li><li>■ Remove pavement surface defects</li><li>■ Remove permanent markings</li></ul>

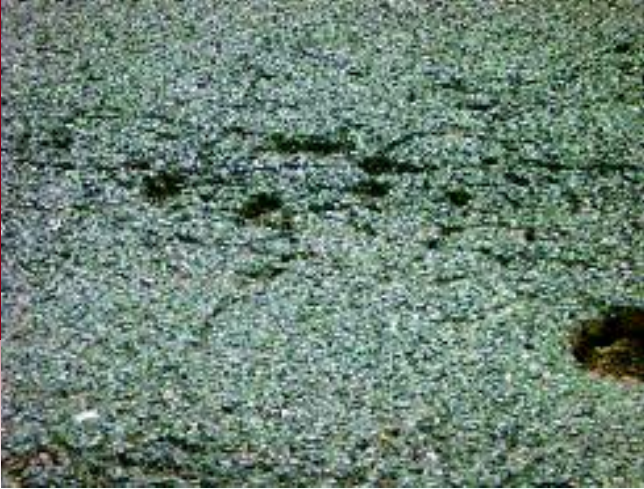
## 3.2

**Description:**  
Cracking and disintegration  
of surface course

Prevention tips
<ul style="list-style-type: none"><li>■ Construction mistakes</li><li>■ Improper mix design for the intended purpose</li><li>■ Non-compliance with type test</li><li>■ Material embrittlement</li><li>■ Poor layer bonding</li></ul>		<ul style="list-style-type: none"><li>■ Degradation of surface course</li><li>■ Surface course fails to transmit loads to the underlying layer</li></ul>	<ul style="list-style-type: none"><li>■ Reinstatement surface course with the following measures:<ul style="list-style-type: none"><li>■ slurry seal,</li><li>■ surface treatment,</li><li>■ slurry surfacing,</li><li>■ thin hot-mix overlay</li></ul></li><li>■ Remove and replace surface course in the failed sections</li></ul>	<ul style="list-style-type: none"><li>■ Review the mix type</li><li>■ Select proper material and technique to produce layer bonding</li><li>■ Initial visual inspection of mix; reject sub-optimal mix</li><li>■ Select and use the correct equipment</li><li>■ Take weather conditions into account.</li></ul>

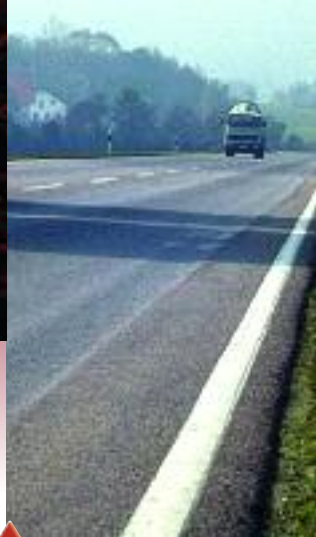
## 3.4

Displacement, e. g. upheaval, rutting etc.

- Improper structural design
- Improper mix design for the intended purpose
- Non-compliance with type test
- Construction mistakes
- Poor layer bonding

- Irregularities
- Variations in layer thickness
- Puddle formation (bird bath) and ice
- Poor riding comfort
- Traffic safety hazard
- Structure will wear away

- Reinstatement with the following measures:
  - milling
  - leveling with thin hot-mix overlay/slurry surfacing
- Replacement

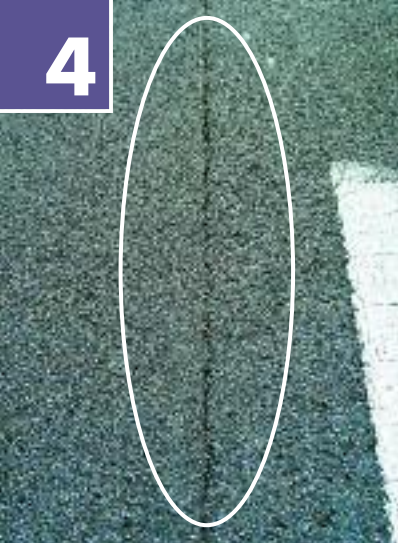
## 4.1 Longitudinal joints – „hot to hot“ method

**Description:**  
 Rough joint edges

Prevention tips
<ul style="list-style-type: none"> <li>Distance between pavers during echelon paving is too great</li> <li>Segregation</li> <li>No roller pattern or improper roller operation</li> </ul>	<ul style="list-style-type: none"> <li>Infiltrating water will open the joint and cause damage to the underlying pavement courses</li> <li>Pavement ravels and erodes along the joint, causing deterioration</li> </ul>	<ul style="list-style-type: none"> <li>Reinstatement of joint area through the following measures:               <ul style="list-style-type: none"> <li>apply tack coat and fine aggregates (grit)</li> <li>apply asphalt repair slurry or pore-filling material</li> </ul> </li> </ul>	<ul style="list-style-type: none"> <li>Define a paving regime and roller pattern</li> <li>Pavers should stay as close to each other as possible during echelon paving</li> </ul>

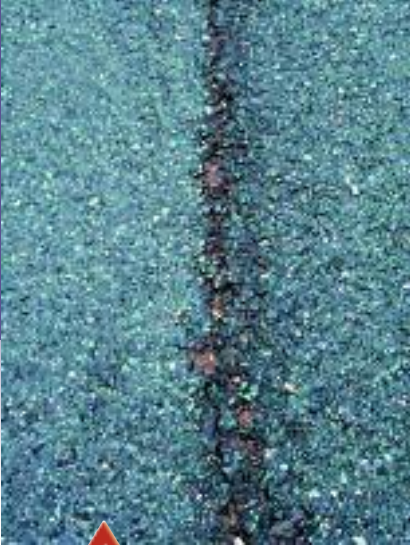
## 4.2 Longitudinal joints – „hot to hot” method

**Description:**  
Open joint

Prevention tips
<ul style="list-style-type: none"><li>■ Distance between pavers during echelon paving is too great</li><li>■ Screed plate has not been preheated</li><li>■ Segregated mix and/or excessive cooling of mix</li><li>■ No roller pattern or improper roller operation</li></ul>	<ul style="list-style-type: none"><li>■ Water infiltration</li><li>■ Pavement is raveling and eroding along the joint</li><li>■ Damage to underlying layers</li></ul>	<ul style="list-style-type: none"><li>■ Over banding of open joint</li><li>■ Cut joint and fill with liquid sealant</li><li>■ Remix joint area</li><li>■ Replace the surface course by applying a longitudinal patch to the distressed centerline area</li></ul>	<ul style="list-style-type: none"><li>■ Specify a paving regime and roller pattern</li><li>■ Pavers should work at the closest possible distance during echelon paving</li><li>■ Pre-heat all parts of the screed plate</li><li>■ Make sure that joint edges are compacted</li></ul>

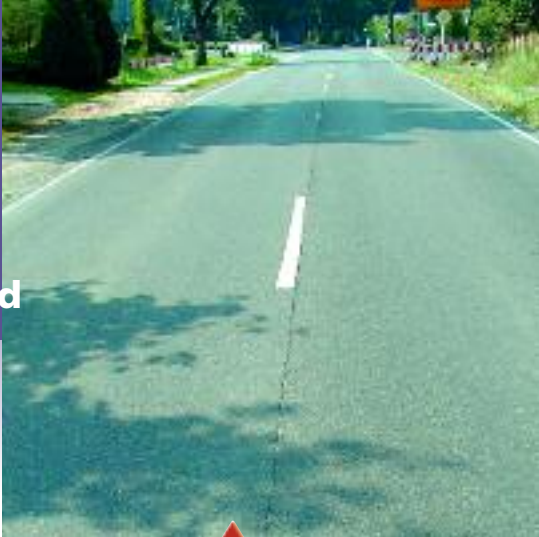
## 4.4 Longitudinal joints – „hot to cold” method

**Description:**  
Open joint

Prevention tips
<ul style="list-style-type: none"><li>■ Poor construction of the joint due to insufficient and/or improper priming of the exposed edges</li><li>■ Inadequate compaction of the mix placed along the joint</li><li>■ No roller pattern or incorrect roller operation</li></ul>	<ul style="list-style-type: none"><li>■ The open joint will allow intrusion of water which will destroy layer bonding</li><li>■ Pavement ravels and erodes along the joint causing deterioration</li><li>■ Damage to underlying pavement courses</li></ul>	<ul style="list-style-type: none"><li>■ Over banding of joint</li><li>■ Cut joint and fill with liquid sealant</li><li>■ Remix joint area</li><li>■ Replace the surface course by patching the distressed centerline area</li></ul>	<ul style="list-style-type: none"><li>■ Define a roller pattern</li><li>■ Restrain the edge of the first lane using the edge-restraining device to form an inclined face (70 - 80°). It is not recommended to cut back the first lane (slurry)</li><li>■ Follow the manufacturer's instructions when applying the primer or tack coat</li><li>■ Preheat the joint face with indirect heat (avoid naked flame)</li><li>■ Create a gap joint and seal it with filling material</li></ul>

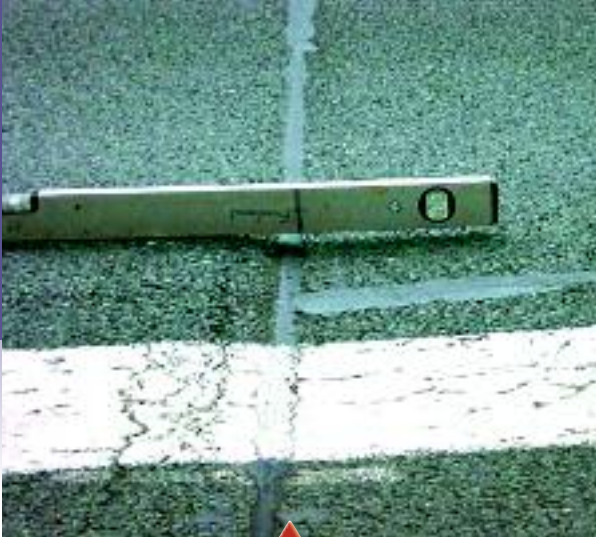
## 4.6 Transverse joints

**Description:**  
Linear surface depression

Prevention tips
<ul style="list-style-type: none"><li>■ Layed mix is not cut back to a sufficient degree</li><li>■ Layed mix is cut back prematurely</li></ul>	<ul style="list-style-type: none"><li>■ Transition area along the joint wears away</li></ul>	<ul style="list-style-type: none"><li>■ Ensure that the upstream and downstream lane have the same elevation</li><li>■ Replace transition area along the joint</li></ul>	<ul style="list-style-type: none"><li>■ Verify evenness with a 4 m straightedger</li><li>■ Ensure that joint face is put back enough</li><li>■ Ensure that layed mix is only cut back immediately prior to paving operations</li></ul>

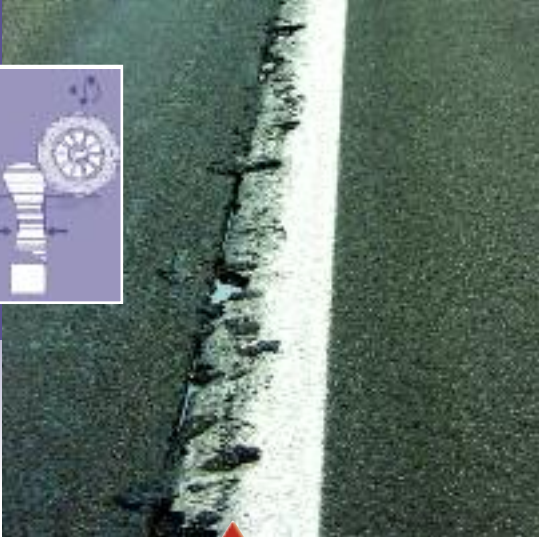
## 4.8 Gap joints sealed with hot-pour filler

**Description:**  
Loss of joint sealant

Prevention tips
<ul style="list-style-type: none"><li>■ Reservoir was not cleaned</li><li>■ No preparatory treatment (primer)</li><li>■ Sealant degraded due to overheating</li><li>■ Excessive amount is applied to joint</li><li>■ Reservoir is too narrow or too wide</li><li>■ Insufficient amount is applied</li><li>■ Wrong location of the joint (in the wheel path)</li></ul>	<ul style="list-style-type: none"><li>■ Entry of water and dirt</li><li>■ Loss of elasticity and adhesion (sealant)</li><li>■ Tracking</li><li>■ Pavement is raveling and eroding along the joint</li><li>■ Damage to underlying layers</li></ul>	<ul style="list-style-type: none"><li>■ Cut faces of joint and apply liquid sealant</li><li>■ Replace the distressed joint area by patching</li><li>■ Remove any excess material</li></ul>	<ul style="list-style-type: none"><li>■ Apply primer only when faces are clean and dry</li><li>■ Follow manufacturer's application instructions</li><li>■ Locate joint outside the wheel path</li><li>■ Ensure that correct amount of filler/sealer material is used for the joint being treated</li></ul>

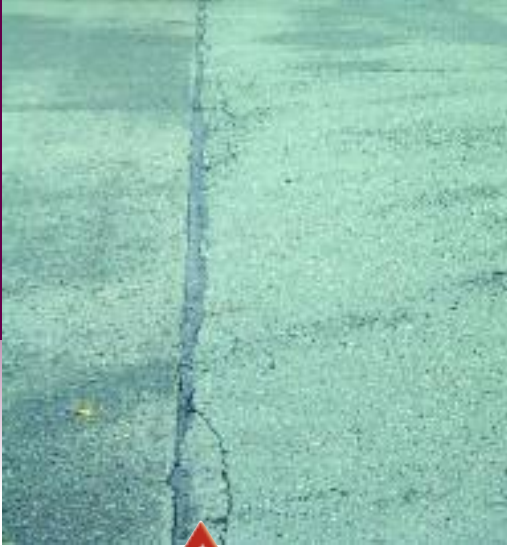
## 5.2

**Description:**  
Crack along the joint

Prevention tips
<ul style="list-style-type: none"><li>■ No gap joint at all</li><li>■ No cutting/routing of gap joint</li></ul>	<ul style="list-style-type: none"><li>■ Water infiltration will cause degradation of the surface course and underlying pavement courses</li></ul>	<ul style="list-style-type: none"><li>■ Rework the gap joint/construct a new joint</li></ul>	<ul style="list-style-type: none"><li>■ Apply joint tape or liquid sealant according to the manufacturer's instructions</li></ul>

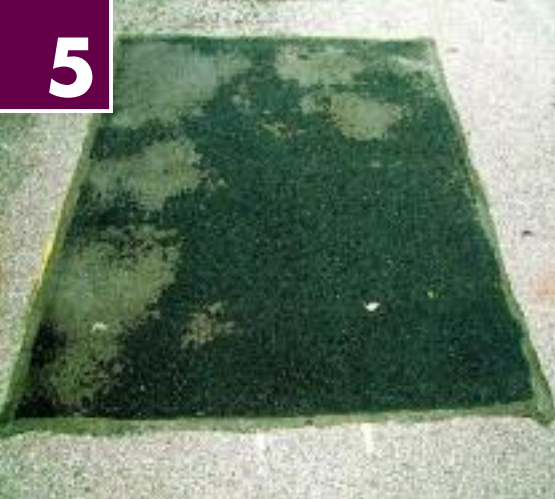
## 5.3

After rain the surface of the patch stays damp for a longer time than the surrounding area.

- Loss of cement causing degradation of the surface course due to entry of water and frost

- Surface dressing
- Remove and replace damaged surface course material

- Ensure compliance with tolerance range when paving
- Select appropriate surface course material (if need be mastic asphalt)

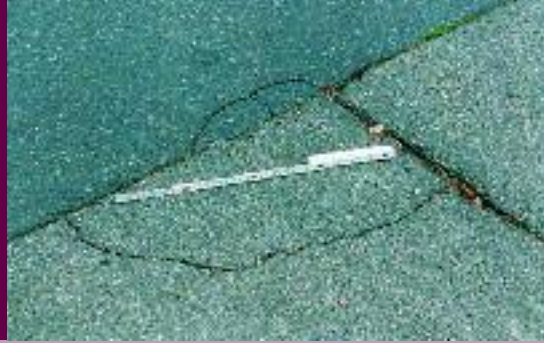
## 5.4

Settlement of asphalt patch and the adjoining areas

Prevention tips
<ul style="list-style-type: none"><li>■ No cutback</li><li>■ Inadequate compaction of the unbound layers</li></ul>	<ul style="list-style-type: none"><li>■ Irregularities</li><li>■ Cracking</li><li>■ Backwater causing spalling/ degradation</li></ul>	<ul style="list-style-type: none"><li>■ Level out the settlement with appropriate material</li><li>■ Cut back the material as far as required, remove the patch material, compact unbound layers and place new asphalt layers</li></ul>	<ul style="list-style-type: none"><li>■ Ensure sufficient compaction of subgrade</li><li>■ Cut back material to specifications</li></ul>

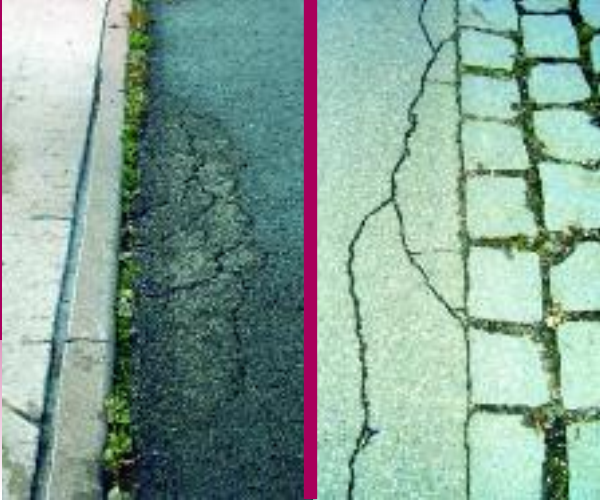
## 6.2

**Description:**  
Road distress due to defects in the kerb/channel area, parallel cracks in the roadway adjoining the kerb, spalling in the kerb area

- Concrete bed protrudes into the pavement
- Insufficient laying of mix in the kerb area
- No longitudinal gap joint along the kerb
- Poor longitudinal gap joint along the kerb

- Progressive crack formation
- Progressive spalling/ degradation

- Construct the missing gap joint
- Replace cold/hot pour material
- Repair cracks
- Cut back the degraded area, cut off protruding concrete bed vertically
- Place new asphalt layer and construct gap joints

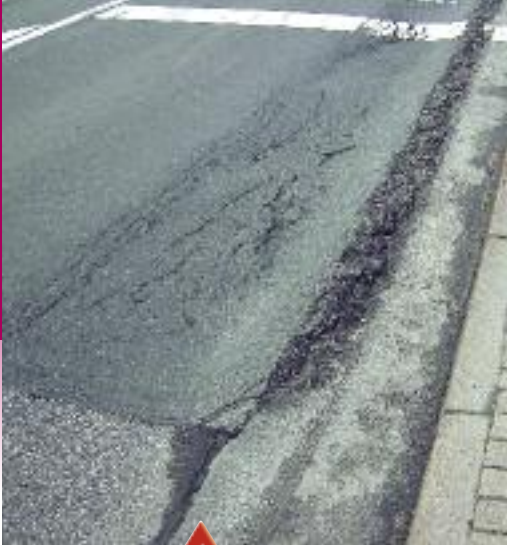
## 6.4

**Description:**  
Overlay on channel

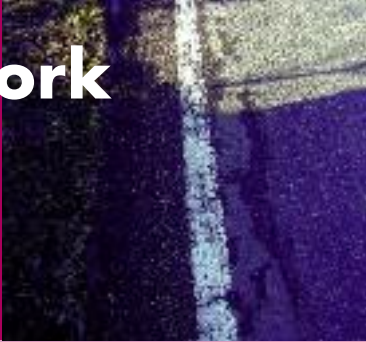
**Description:**  
Degradation of asphalt edge along road shoulder

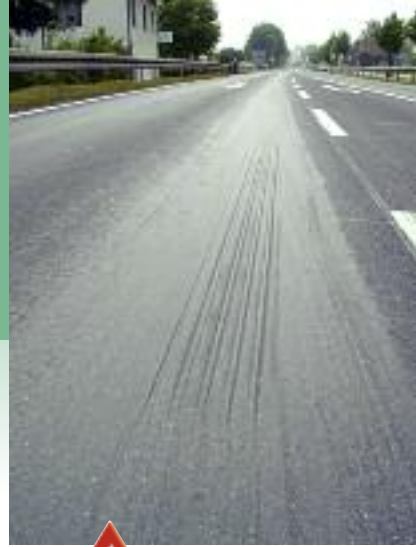
## 7.2

### Description: Poor skid resistance

- Aggregates with low Polished Stone Value (PSV) in mix and gritting
- Excess of binder in the asphalt mixture
- Binder is too soft for the intended use
- Gritting is applied too late
- Aggregates for gritting are moist and not de-dusted
- Incorrect roller operation and rolling pattern

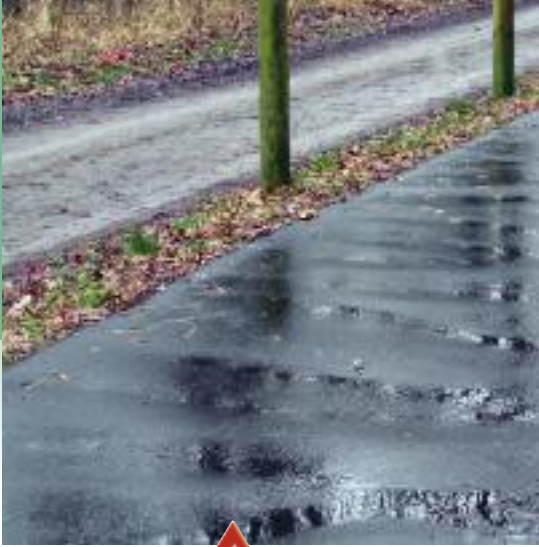
7.4

**Description:**  
**Inadequate Evenness**

Possible causes	Possible effects on performance	Solutions	Prevention tips
<ul style="list-style-type: none"><li>■ Temperature fluctuations of mix</li><li>■ No steady feed of material to paver</li><li>■ Wrong settings for paver</li><li>■ Incorrect roller operation and compaction technique</li><li>■ Handwork</li><li>■ Varying surface course thicknesses</li><li>■ Inadequate base course</li><li>■ Adverse weather conditions</li></ul>	<ul style="list-style-type: none"><li>■ Surface irregularities (e. g. wash-boarding)</li><li>■ Traffic disruptions</li></ul>	<ul style="list-style-type: none"><li>■ Fine milling</li><li>■ Replace surface course</li></ul>	<ul style="list-style-type: none"><li>■ Ensure that base course is even (level out base course, if need be)</li><li>■ Ensure steady feed of material to paver</li><li>■ Run paver further than needed, if need be</li><li>■ Adjust initial compaction in screed unit</li><li>■ Ensure compliance with tolerance ranges</li><li>■ Adjust roller operation and rolling pattern to type of mix and temperature</li></ul>
